**REVESTIMENTOS COMPATÍVEIS PARA
ALVENARIAS ANTIGAS SUJEITAS A AÇÃO
SEVERA DA ÁGUA**

Tese elaborada no Laboratório Nacional de Engenharia Civil (LNEC) e apresentada à Universidade de Aveiro para cumprimento dos requisitos necessários à obtenção do grau de Doutor em Engenharia Civil, realizada sob a orientação científica da Doutora Engenheira Maria do Rosário da Silva Veiga, Investigadora Principal com Habilitação do Laboratório Nacional de Engenharia Civil e da Professora Doutora Ana Luísa Lomelino Velosa, Professora Associada do Departamento de Engenharia Civil da Universidade de Aveiro

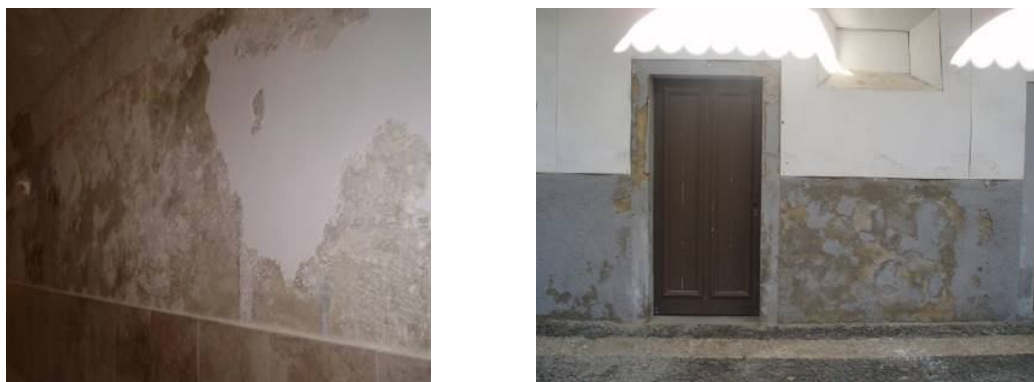
Fig. 2.3 (a) Destacamento do acabamento interior composto por reboco/pintura impermeável (a parede é revestida com mármore até 1,2 m, acima da qual ocorreu o destacamento da pintura); (b) destacamento do reboco de cimento e pintura impermeável exteriores devido à dificuldade de evaporação.

Na Fig. 2.3 apresentam-se casos de degradação associados à presença de sais solúveis e humidade ascensional.

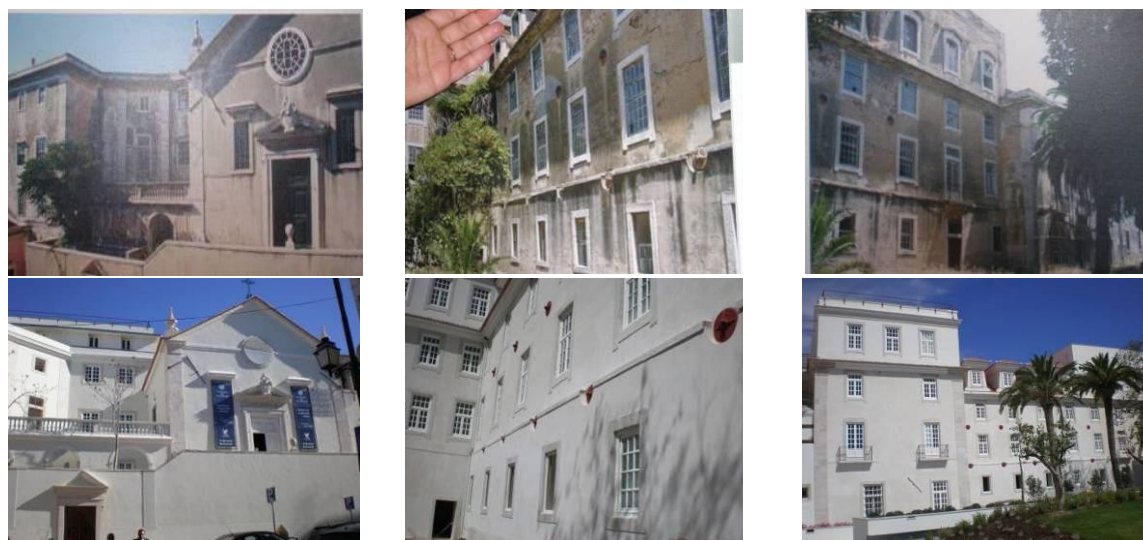
Fig. 3.1 Inglesinhos Convent before and after intervention

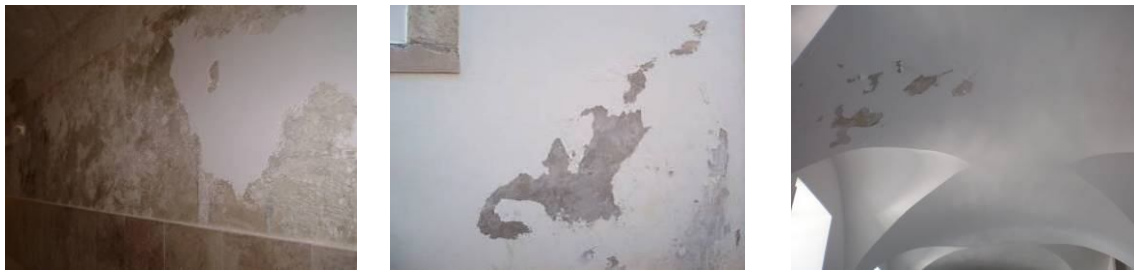
Fig. 3.2 Detachment of the paint: internal facades (left), external facades (middle) of walls and vaults composing the ceilings (right).

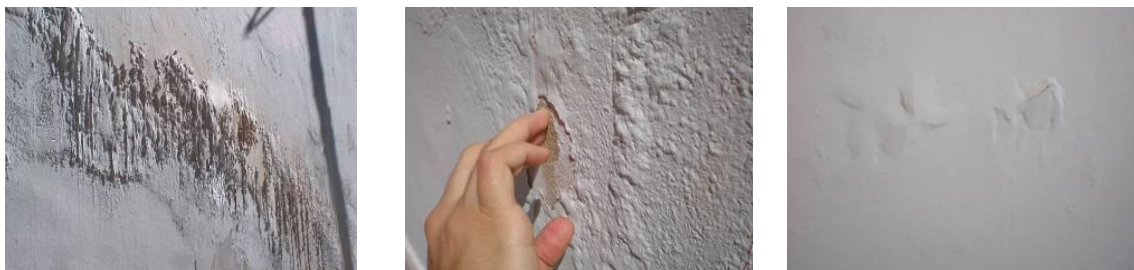
Fig. 3.3 Blistering of the paints in external (left and middle) and internal (right) facades of the walls.

Before the beginning of the works, the roof remained in poor conditions for a long period of time, allowing water infiltrations to reach the vaults that form the ceilings of the ground floor. During the refurbishment works, the old renders and plasters based on air lime were removed and substituted by new ones, composed by lime and cement, in the interior and exterior of the building. The new renders showed shrinkage cracks after application and were treated with a synthetic product designed to reduce shrinkage. Before the end of the works, several anomalies occurred such as: dark moisture stains, salt efflorescences, loss of cohesion of the paint, blistering and detachment of the paint both in external and internal façades (Figs. 3.2 to 3.5).

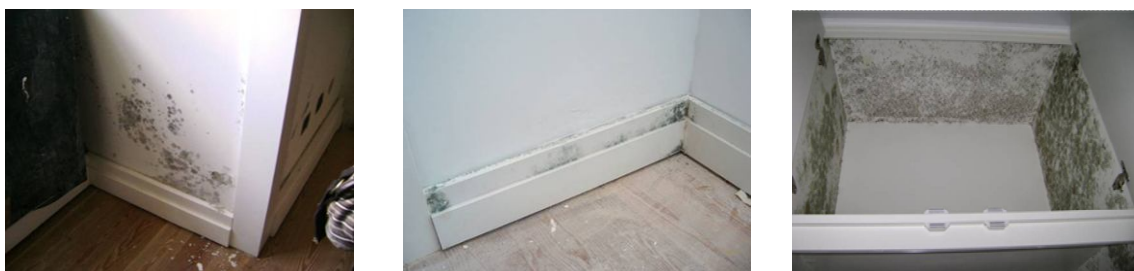
Fig. 3.4 Dark moisture stains: in the base of the walls (left), floor-footers (middle) and built-in cupboards (right).

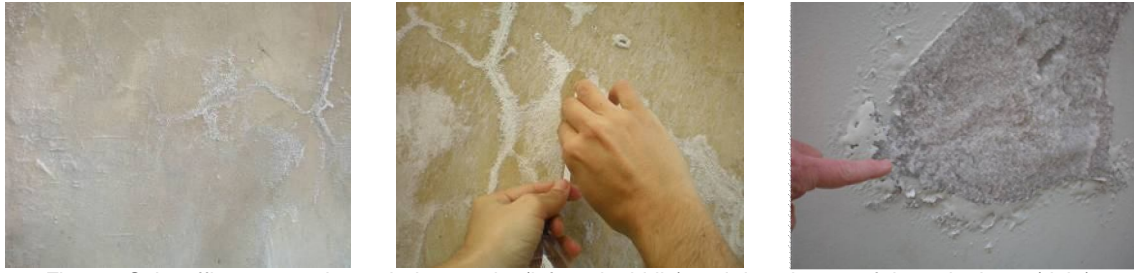
Fig. 3.5 Salts efflorescence in rendering cracks (left and middle) and detachment of the paint layer (right).

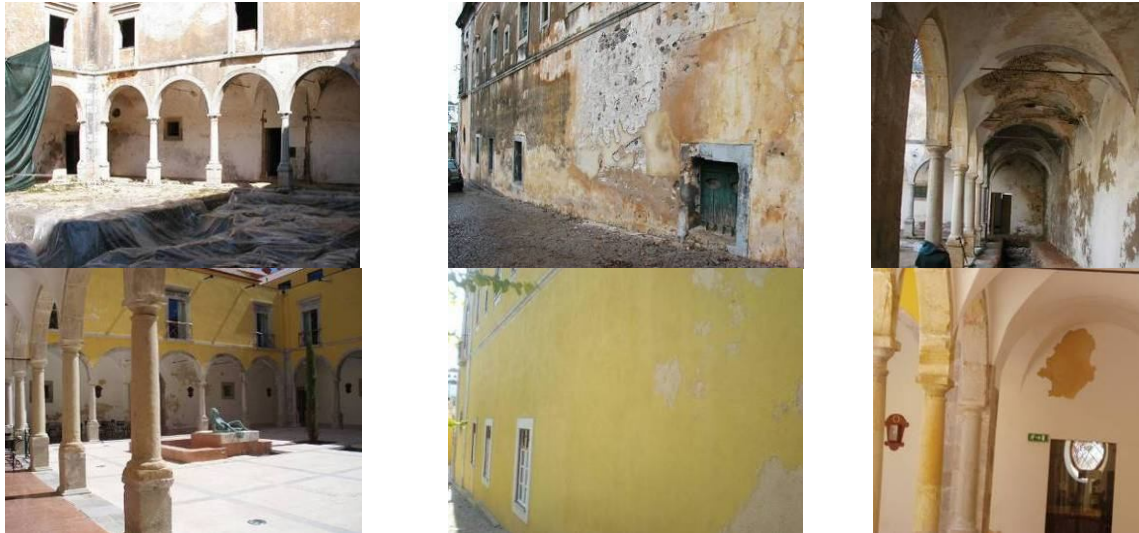
Fig. 3.6 Tavira Charm Hotel before and after intervention

The old renders and plasters were based on lime, especially visible in the renders in the cloister area. In Figure 3.6 the building before and after intervention is presented.

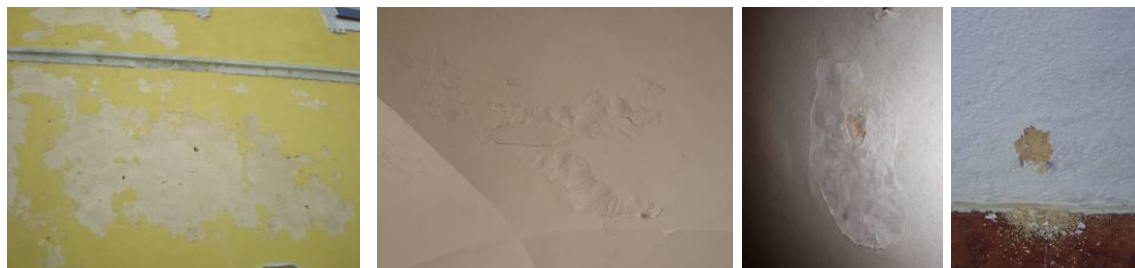
Fig. 3.8 Detachments of paint in the exterior facade (left), in the vaults (middle) and in the interior plaster (right) near the floor-footers

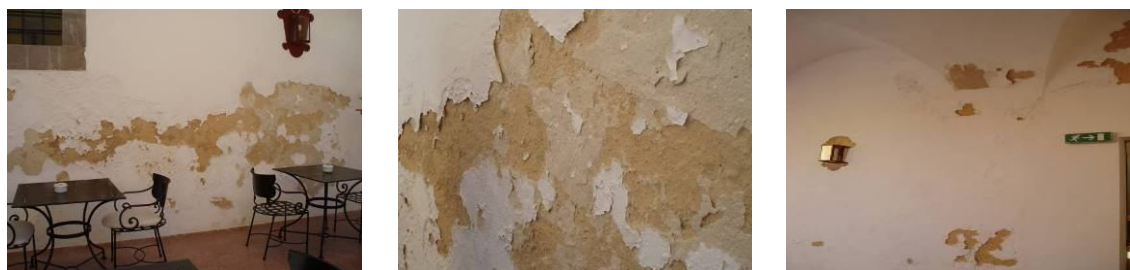
Fig. 3.9 Detachment, loss of cohesion and salts efflorescence in the renders (left) and in the vaults (right).

In 2010, several anomalies were observed such as: dark moisture stains, salt efflorescences, loss of cohesion of the paint, blistering and detachments of the paint both in external and internal façades (Figs. 3.8 to 3.11).

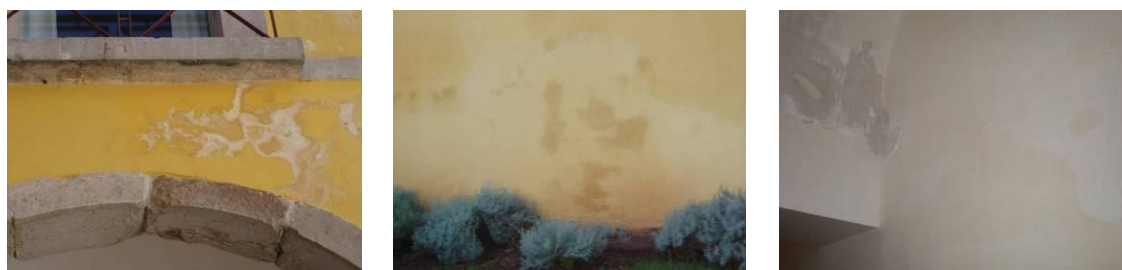
Fig. 3.10 Moisture stains in the exterior facades renders (left and middle) and interior plasters in the vaults (right)

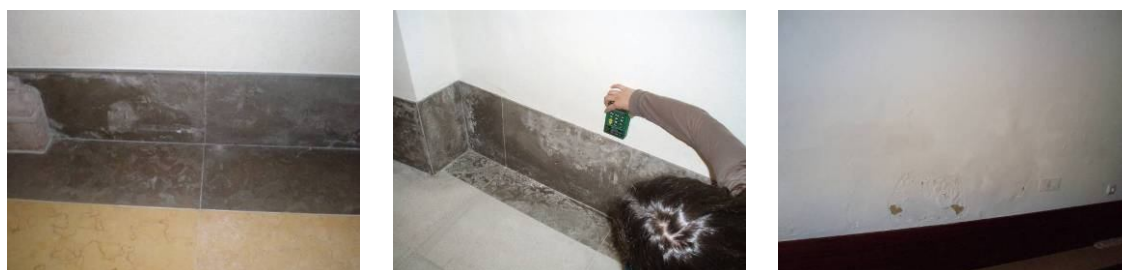
Fig. 3.11 Moisture stains and salts efflorescence in the interior calcareous stone surfaces (left and middle) and blistering of the paint (right) in the interior plaster.

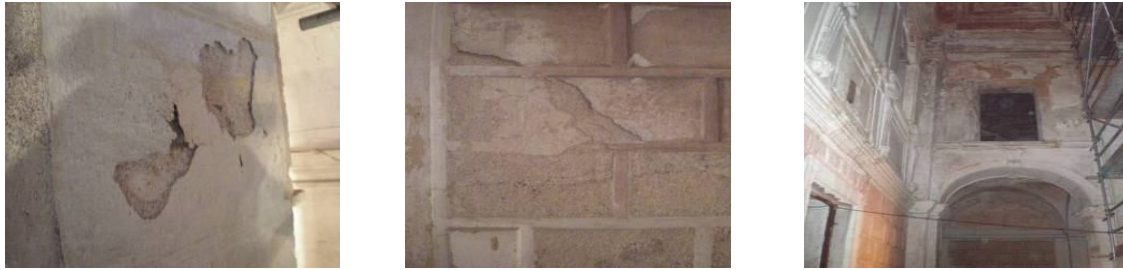
Fig. 3.13 Detachment of the stucco in pillar (left), detachments and cohesion loss in the walls (middle and right).

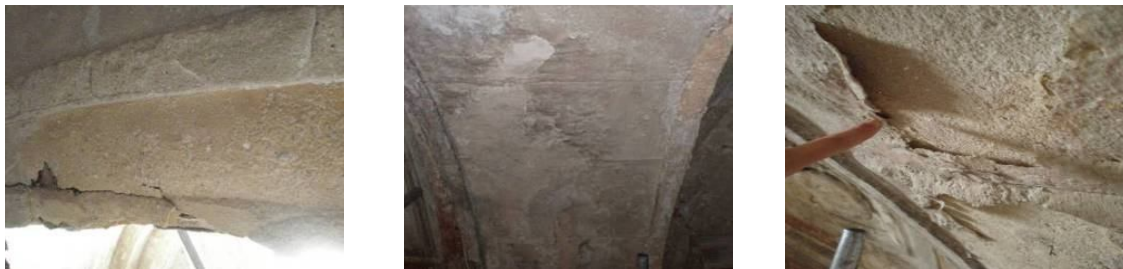
Fig. 3.14 Loss of cohesion in the arch (left); salts efflorescences and detachments of the plasters (middle and right).

In general, the mortars were well conserved and presented interesting mural paintings simulating pink marble, although some detachments, loss of cohesion and salt efflorescence were observed (Figs. 3.13 to 3.15).

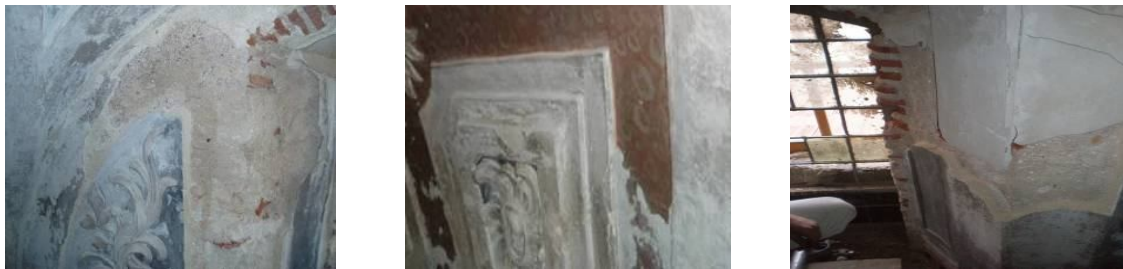
Fig. 3.15 Detachment and loss of cohesion of the stuccos in the dome (left and middle), detachment of the plaster in the dome (right)

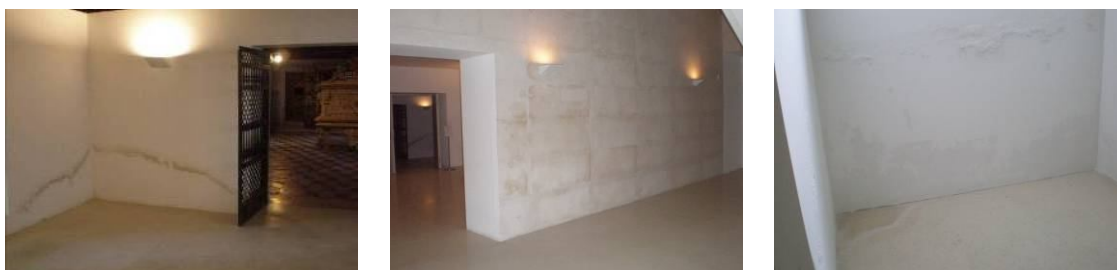
Fig. 3.17 Dark moisture stains in the paint and marble finishing surfaces on interior walls (left and middle), stains of humidity in the floor and detachments of the paint in interior facade of exterior walls (right).

The new plasters presented moisture stains, salts efflorescence and blistering and detachments of the paint. The main decay patterns observed are described in Figures 3.17 to 3.20.

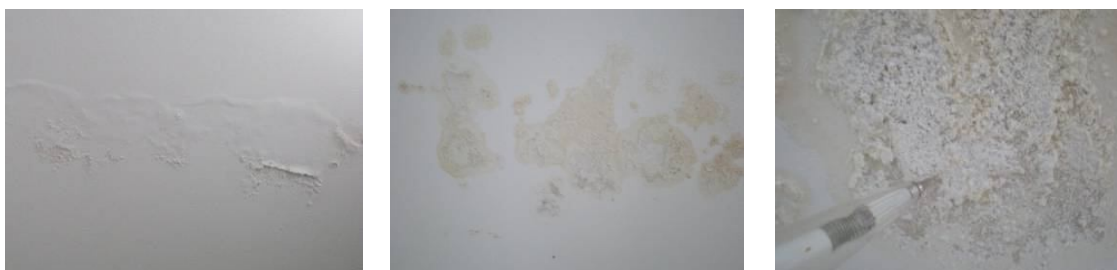
Fig. 3.18 Blistering of the paints (left), dark moisture stains and salt efflorescence (middle), salt efflorescence and detachment of the paint (right).

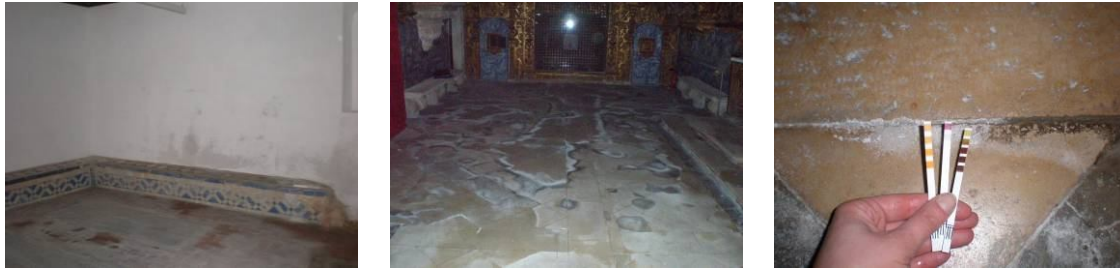
Fig. 3.19 Moisture stains in the ground floor (left and middle) and salts efflorescence in the old floor (right)

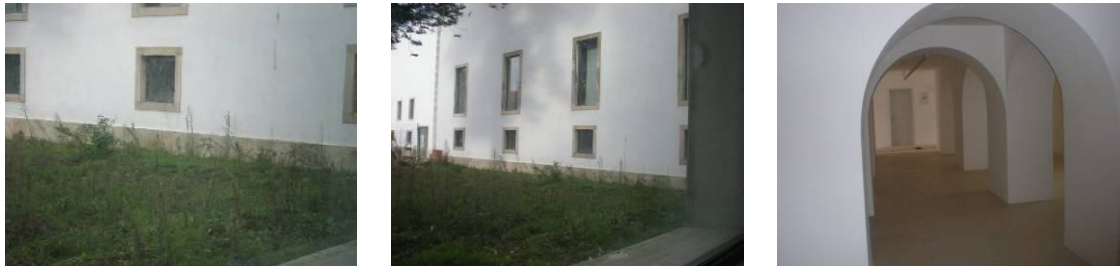
Fig. 3.20 Facades: Dark moisture stains along the plasters, efflorescences, detachments of the paint.

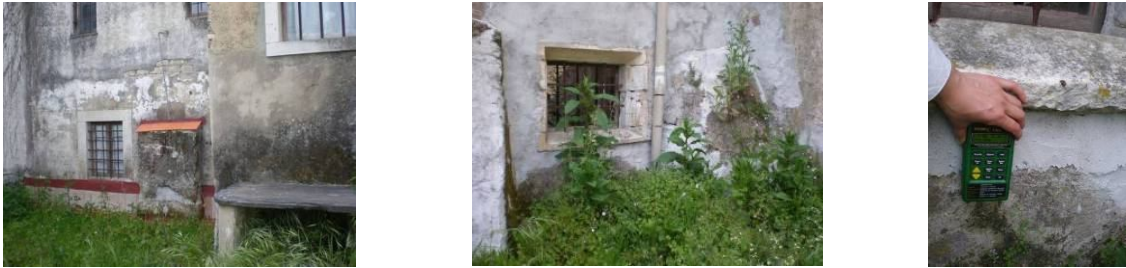
Fig. 3.22 Exterior facade: dark moisture stains, detachments of plasters and paints (very damaged), presence of cement renders due to local substitutions along time.

The renders and plasters were very damaged with generally salts efflorescence, detachments, loss of cohesion and humidity spots. The main decay patterns observed are described in Figures 3.22 to 3.28.

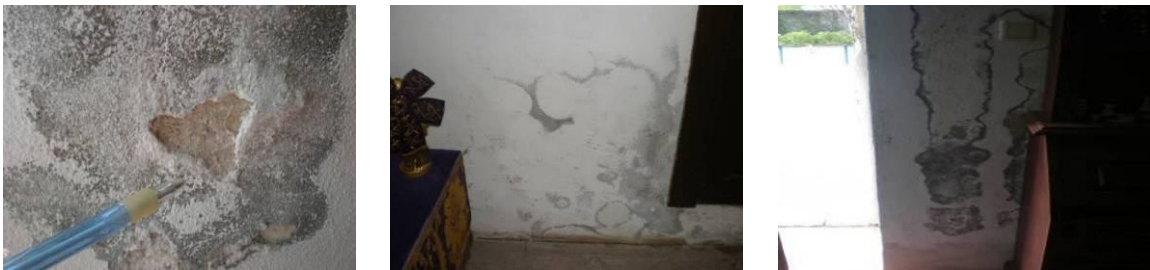
Fig. 3.23 Interior facades: salts efflorescence and detachment of plaster (left), dark moisture stains (middle and right) - ground floor.

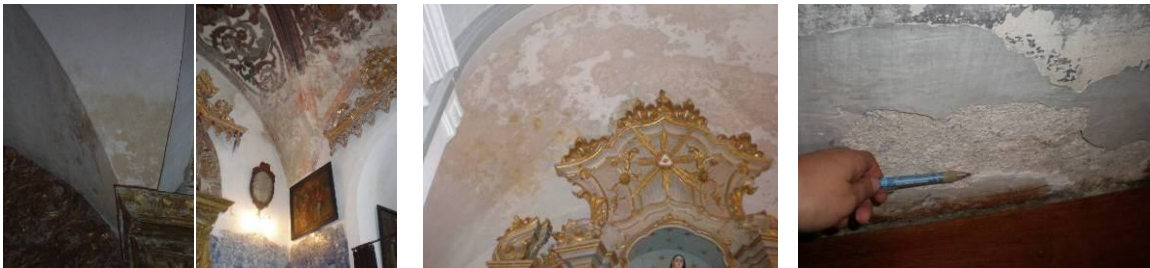
Fig. 3.24 Moisture in the vaults (left) and ceilings of the church (middle), detachment of plasters in the base of the walls (right).

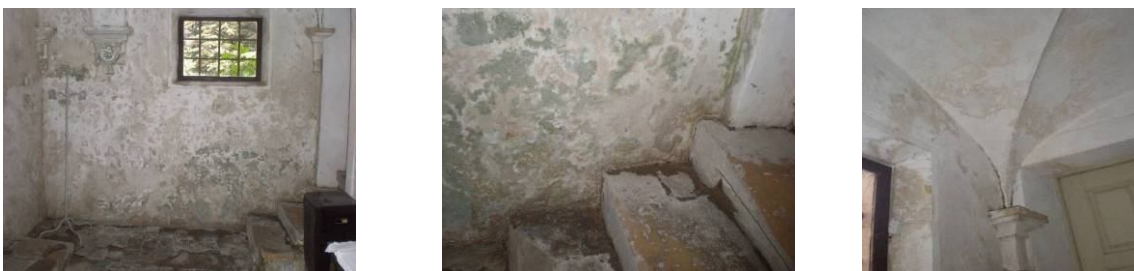
Fig. 3.25 Dark moisture stains and biological colonization since the base of the exterior wall (left), moisture in the base and stairs (middle), moisture in the vase of the vaults and ceilings (right) – ground floor.

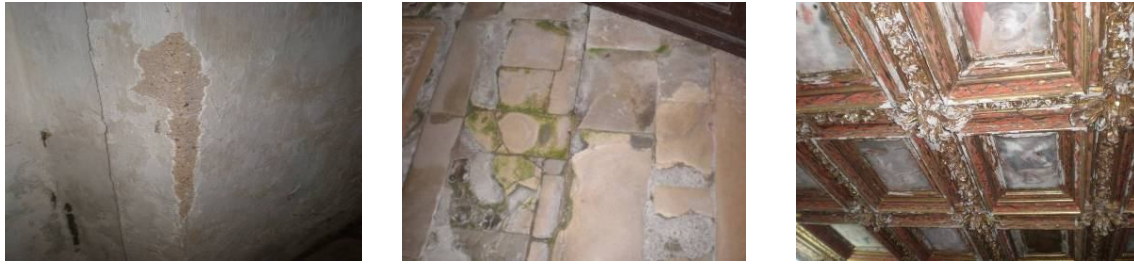
Fig. 3.26 Detachment of plasters Interior wall (left), moisture stains and biological colonization in the floor (middle); damage in the wood ceiling due to moisture (right) – ground floor.

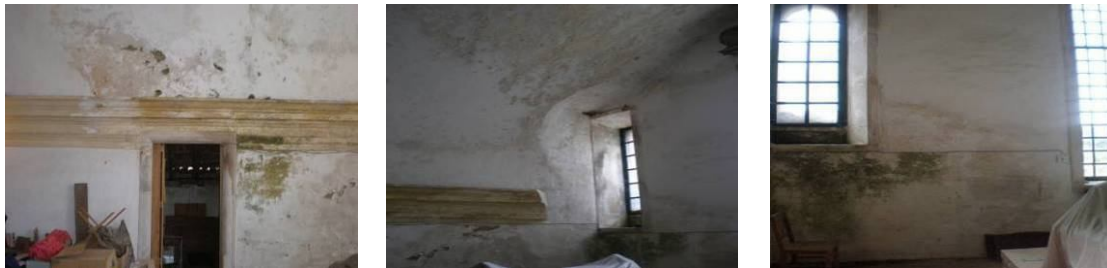
Fig. 3.27 Biological colonization, moisture stains and detachment of plasters (left); moisture stains in the ceiling (middle); moisture and biological colonization and presence of cement plasters (right) – upper floor.

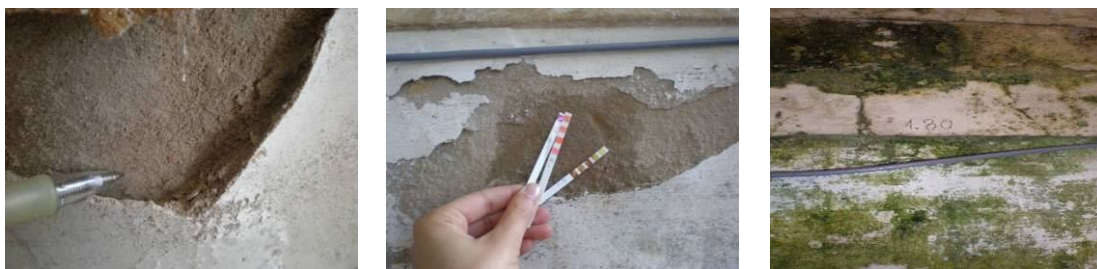
Fig. 3.28 Detachment of the plaster (left); detachment of the paint, loss of cohesion and salts efflorescence (middle) and biological colonization (right) – upper floor.

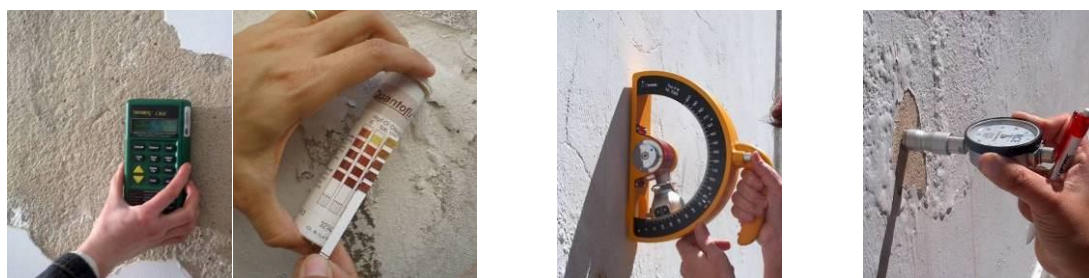
Fig. 3.29 In situ test with portable humidimeter, strip tests, impact hammer and durometer (from left to right).

Non-destructive diagnosis was performed in situ using a methodology [Mag08b] based on visual observation of the anomalies, determination of the superficial moisture content and resistance and semi-quantitative identification of salts using simple equipment: a portable humidimeter, durometer,

impact hammer and strip tests (Fig. 3.29). This methodology was used in the several case studies, except in case studies SJM and SAC in which only superficial moisture and salt strip tests were performed, due to some difficulties in transporting the impact hammer and durometer equipment.

A portable humidimeter – Tramex CRH - was used to evaluate the superficial moisture content in the walls [Vei09c, Mas93, Hen01]. This test was performed in several internal and external walls, at different heights - between 0.10 m and 1.80 m from the pavement following one vertical profile per wall/area. In some case studies they were performed at two different periods – dry weather and after a rainy week – in order to determine the possible origin of the water. This equipment presents a range of values from 0 to 6.9, corresponding to a dry and very wet render, respectively, based on electric resistance, function of the water content of the material in which the equipment is in contact. Values between 0 and 2 correspond to dry zones; 2 to 4 correspond to slightly humid zones, 4 to 6 humid zones and from 6 to 6.9 to very humid zones [Mag08b, Mag09a, Vei09b, Fra11b]. The superficial moisture content values in each case are related to the walls/areas where higher moisture content was observed. Hygroscopic salts may influence these values in isolated points, so the measurements should be done in several points and related with salt content evaluation, in order to identify this influence. On the other hand, a relevant general influence of salt contamination on the electric resistance values obtained was not detected. Reference values are also presented and the values are comparative and not absolute.

The strip tests were used for the semi-quantitative identification of salts in wall areas where salts efflorescence/damage were observed. They give information on the type of salts present as well as on the degree of contamination, based on semi-quantitative determination of ions associated with the type of salts [Bor99]. In renders of old buildings the most used strip tests are the ones corresponding to chlorides, sulphates and nitrates. The presence of sulphates can be associated to the presence of cement, some kinds of hydraulic limes in the mortars or some ceramic materials if not fired adequately, as well as to the atmospheric pollution [Arn89]; in spite of the lower dissolution rate of sulphates, when compared with the other salts present, the circulation of water in the walls can promote their dissolution and dissemination [Oto08a]. The chlorides can be associated to marine environment (contact of the building material with sea spray or marine fog), ground water and contaminated soils or to their presence in wall materials (stones, bricks, mortars or sand) (see chapter 2). The presence of nitrates can be due to contamination with organic products, mainly from animals or due to the treatment of the soil with organic fertilizers [Arn89]. The presence of nitrites points out that the moisture source from the ground may remain active or was active until recent times, because these salts are very unstable. [Hen01, Mag08b]. Salts can be transported in a porous material only if dissolved in water, thus their presence indicates water transport through the walls [Lub06a].

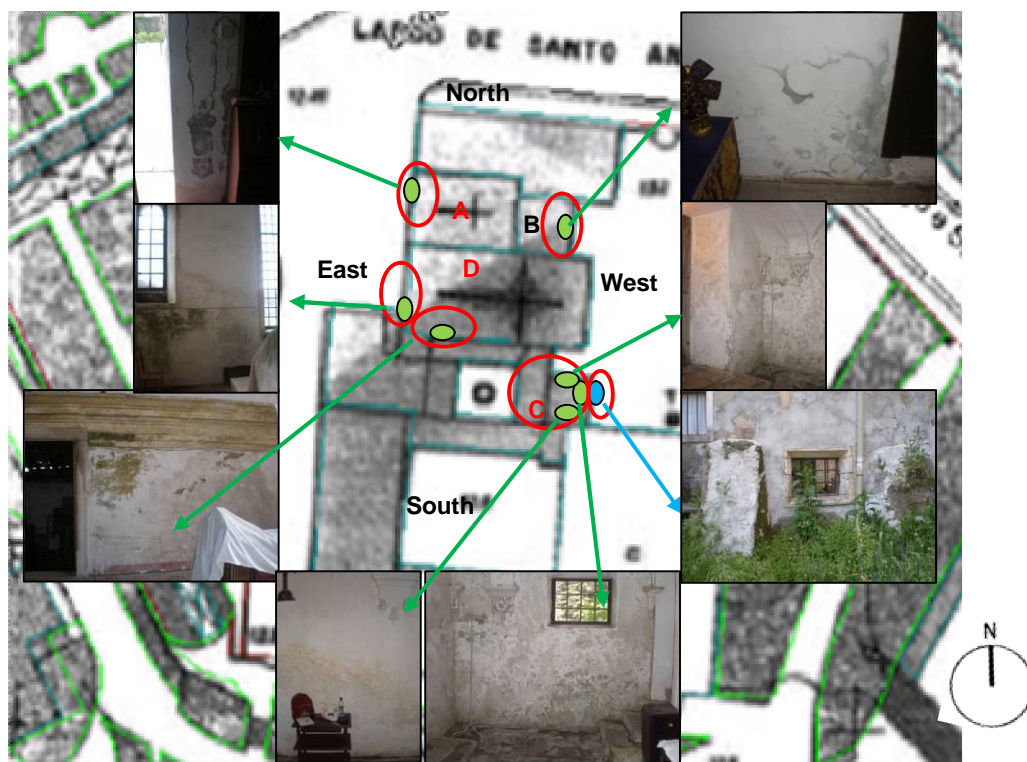
Fig. 3.39 In situ tests localization in the plan – Saint Francis Convent

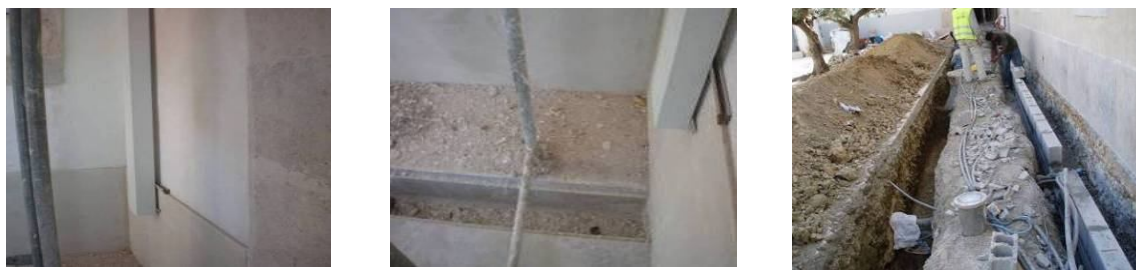
Fig. 3.40 Rainwater collectors and execution of drainage and ventilation ditches along the exterior walls.

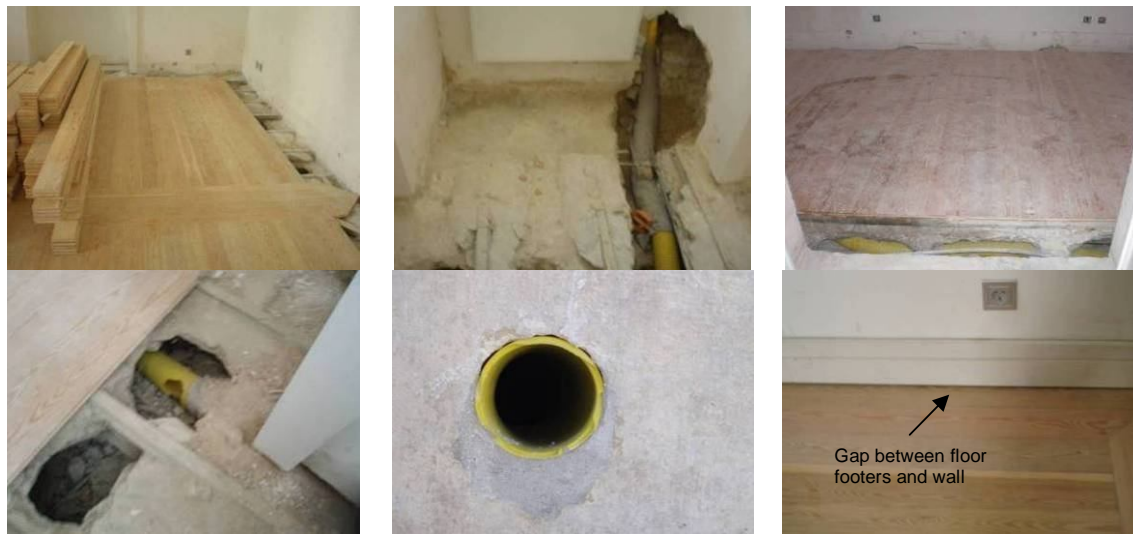
Fig. 3.41 Ventilation tunnels in the interior spaces and gaps between floor footers and the wall.

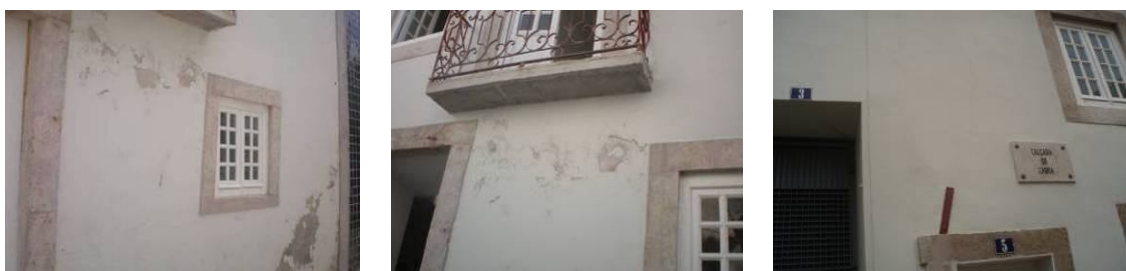
Fig. 3.42 Damage in the external walls due to the use of impermeable renders and paint.

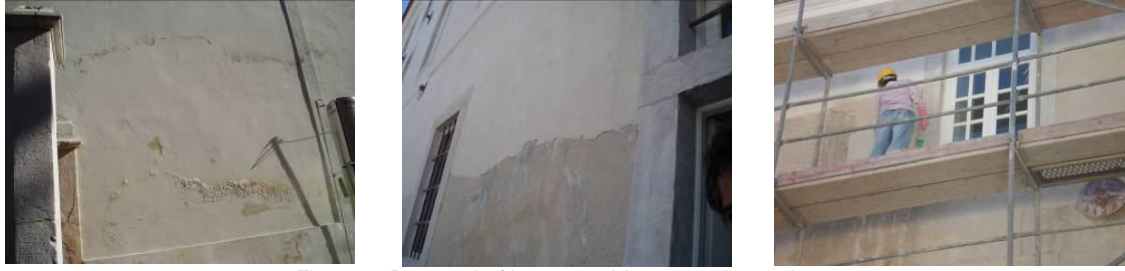
Fig. 3.43 Removal of impermeable external coverings.

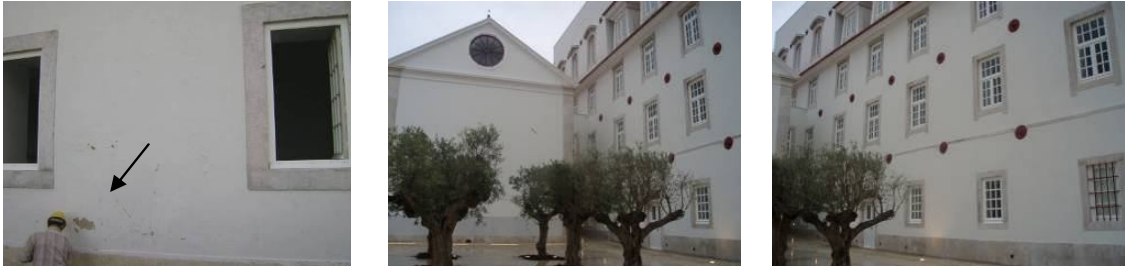
Fig. 3.44 Detachment of the external paint, before intervention (left) and final appearance of the exterior facades (middle and right).

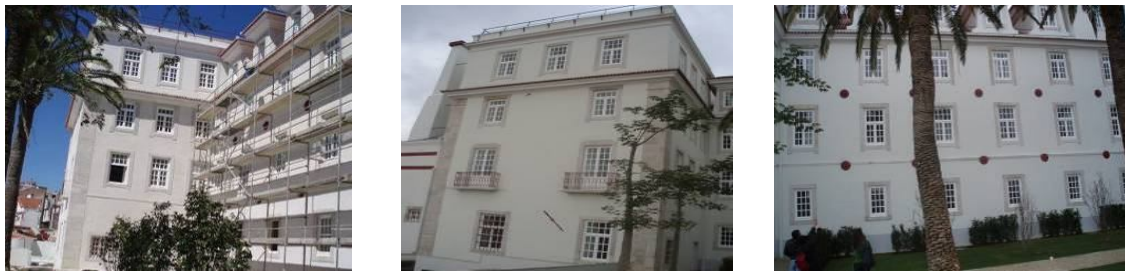
Fig. 3.45 Final appearance of the exterior facades, executed with lime based finishing coat for the regulation of the walls and a silicate based paint.

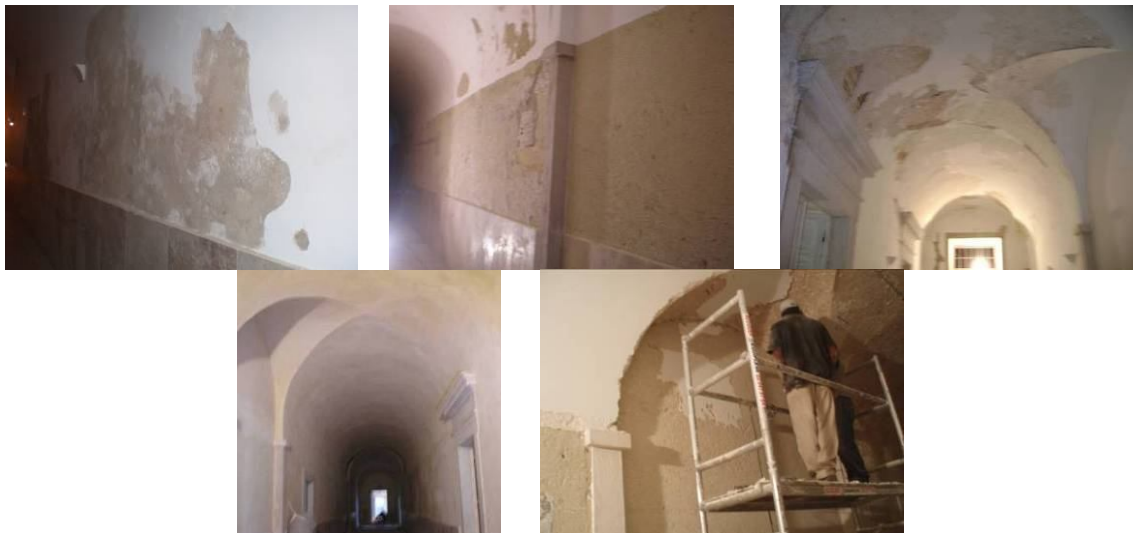
Fig. 3.47 Removal of cement and lime plasters of interior walls and vaults and replacement by air lime and sand mortars covered with a traditional plaster.

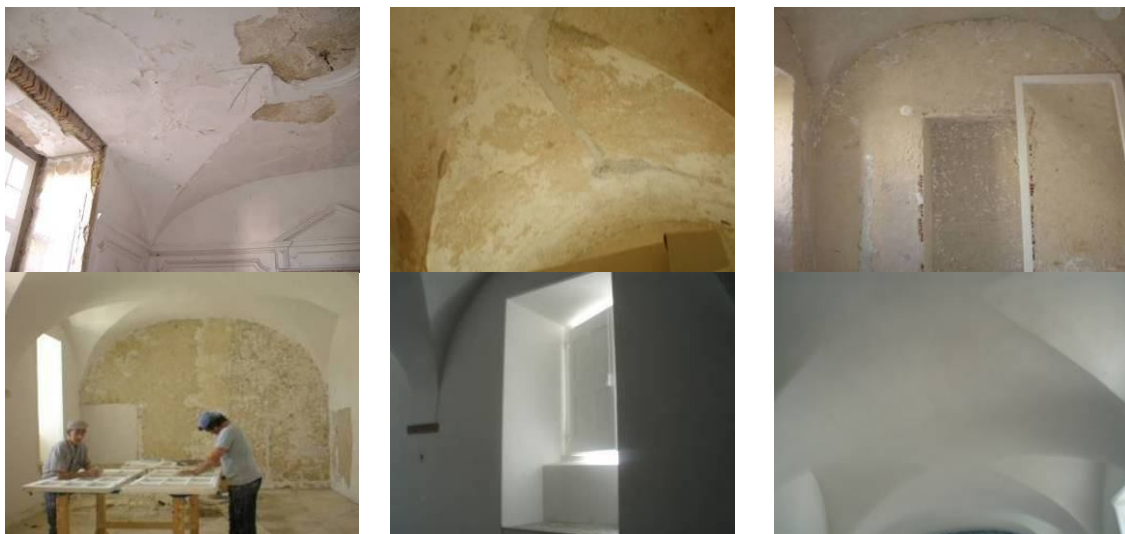
Fig. 3.48 Removal of cement and lime plasters of interior walls and ceilings and replacement by air lime and sand mortars covered with a traditional plaster.

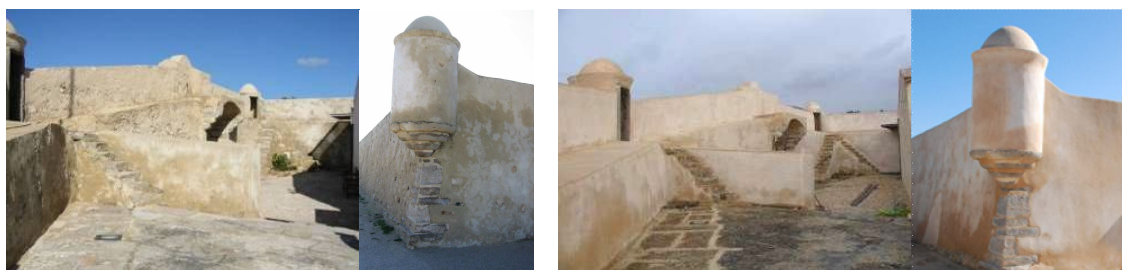
Fig. 3.49 Fortress on the coast of Lisbon (from the XVII century) before intervention (left) and approximately 1.5 years after intervention, after total substitution of renders by air lime and metakaolin mortars (right) [Vei05a, Vei09c]

The studied Fortresses had been submitted to previous intervention and premature anomalies were observed on their renders. In the intervention the original mortars of the Fortress of the XVII century had been substituted by lime based renders with water repellent, which showed severe damage, with generally loss of cohesion; the original mortars of the Fortress of the XVIII century had been substituted by cement mortars showing several anomalies. In both cases the original mortars were composed by air lime.

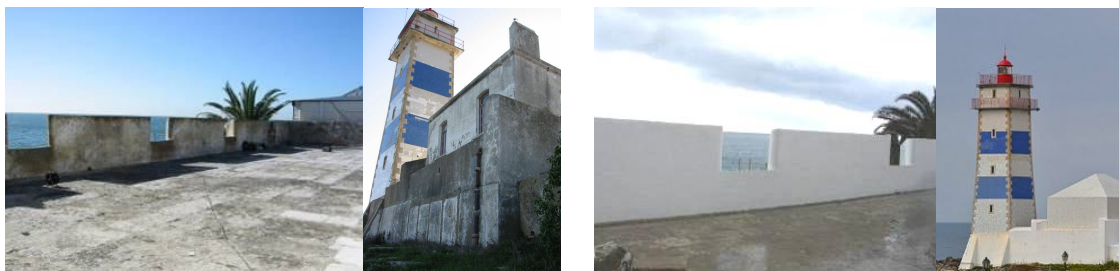
Fig. 3.50 Fortress on the coast of Lisbon (from the XVIII century) before intervention (left) and approximately 6 months after intervention, after total substitution of renders with air lime and cement mortar and silicate paint (right) [Tav08b]

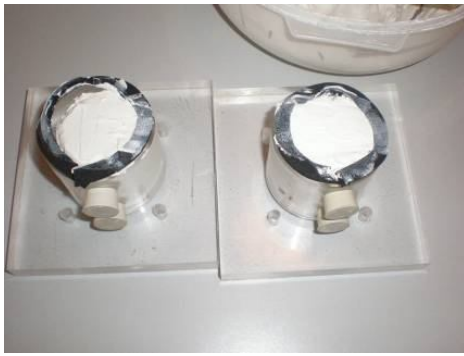
Fig. 4.5 Filling of the plastic electrodes compartments with clay

The specimens were placed between two cylindrical electrode compartments made from polymethyl methacrylate. The internal diameter of the electrode was 4.0 cm and the length was 5.0 cm. The electrode compartments were filled with clay poultice (Fig. 4.5). The clay matrix was defined and mixed in laboratory from kaolin and CaCO_3 after a recipe developed for desalination of brick masonry [Rör08a]. The laboratory setup for the electrokinetic desalination experiments is shown in Fig. 4.6.

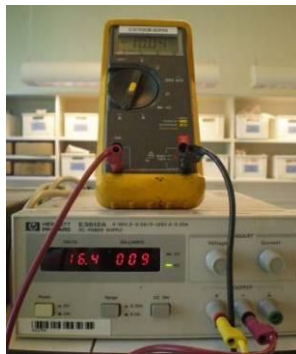
Fig. 4.7 Electrokinetic desalination test: (a) application of the electric DC field with a constant current of 10 mA and (b) specimen for the experiment.

The specimens were wrapped with plastic film during experiments to limit evaporation and subsequent drying of specimen and poultice. The ends of the tubes away from the specimens were closed. On the upper side of the electrode compartments were two holes (1.0 cm diameter). The holes closest to the specimens were closed during the experiments and were not used in this setup. In the outer holes the electrodes were placed. They were bar-electrodes (platinum coated) with a diameter of 2.9 mm. The electrodes reached approximately 3.5 cm vertically into the electrode compartments. The electrodes were constructed based on previous work [Ott07a1]. At the top the electrodes were placed in a stopper to close the hole around the electrode. The electrode compartments were filled with clay. A constant current of 10 mA was supplied by Hewlett Packard E3612A power supply (Fig. 4.7).

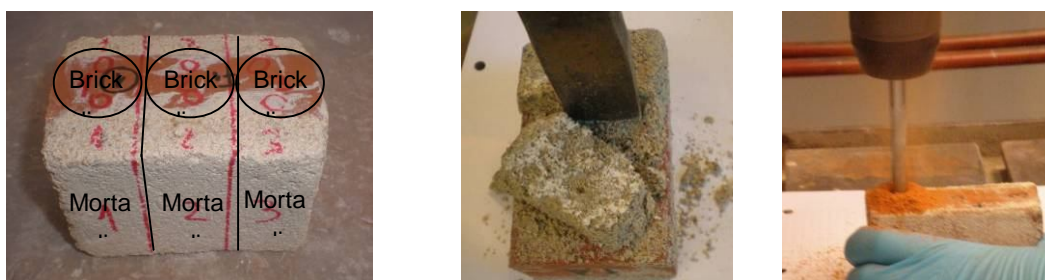
Fig. 4.8 Segmentation of the specimens at the end of the experiments: (a) segmentation of the render in each of the larger sides into three slices and brick into three slices, (b) chisel used for segmentation of the render and (c) mechanical drill for powder brick sample in each brick slice.

At the end, both reference and electrokinetic specimens were segmented into 9 slices. The render in both larger sides of the specimens was separated in three parts: one slice from each end far from the electrodes (designated as A and C) and one in between (designated as B) (Fig. 4.8). The slices had approximately the same dimension. The segmentation was done by hand with a hammer and chisel. The bricks were segmented into 3 slices (slice from each end far from the electrodes and one in between) and from each one a powder sample from the brick was obtained with a mechanical drill.

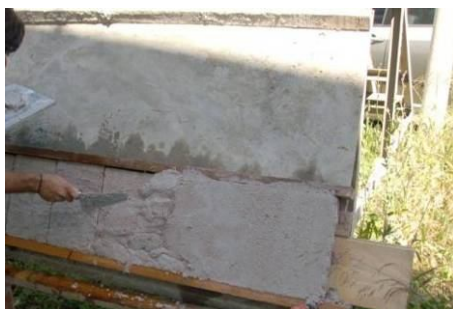
Fig. 5.1 Specimens execution.

the case of L and CRes specimens), to simulate internal plaster and external render on brick masonry (Fig. 5.1).

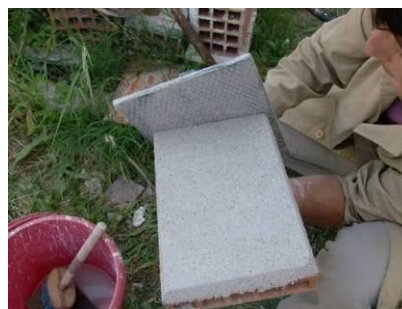
Fig. 5.2 Render execution on perforated brick.

The specimens were carefully executed in order to reduce problems during testing which could be related to inadequate workmanship (Fig. 5.2).

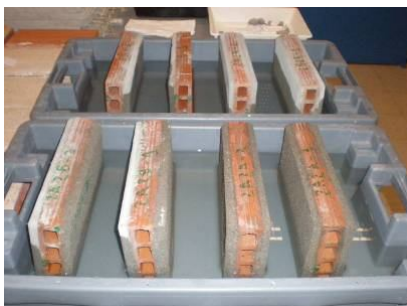
Fig. 5.3 Partially immersion of specimens for dissolution/crystallization cycles reproduction.

After curing, the specimens were subjected to crystallization tests by dissolution/crystallization cycles. They were partially immersed in NaCl solution (27g/L – similar to sea content [Aug90]) (Fig. 5.3) to allow capillary rise through the specimens, reproducing rising damp close to sea, in laboratory conditions (under the same temperature and relative humidity of the air). After each wetting cycle the samples were then dried at 40°C in a ventilated oven, to speed up the drying (Fig. 5.4). The wetting and drying phases of each cycle were prolonged until constant mass of the specimens. The samples were not brushed between cycles. The test stopped when damage in the plaster was found or after 8 dissolution/crystallization cycles.

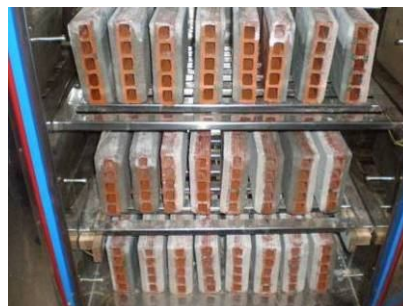
Fig. 5.4 Specimens drying in a ventilated oven at 40°C.

Specimens were not sealed, so the evaporation was able to occur on all sides. Before testing (after curing) they were dried in a ventilated oven at 40 °C until constant mass and afterwards they were left to equilibrate in a conditioned room (20 °C and 65% RH).

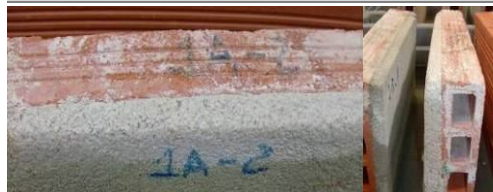
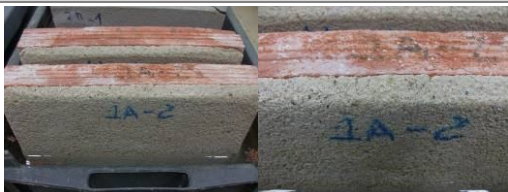
Cycles 4 th cycle		6 th cycle	
Specimen L

Mortar	++(L)	+++	(L)
Brick	++	++	
Specimen L-L

On L, L-L, L-Met, L-C, LMet-LMet and LMet-C, salts appear as "hair crystals" at the end of 4th cycle and evolving to dense crust at the end of 6th cycle, on the top of the brick and on the surface of the renders, but some differences can be observed. On the surface of the renders, salt crystallization appears as generalized "hair crystals" at the end of 4th cycle and dense crust crystallization at the end of 6th cycle although for L, L-L, LMet-LMet these crystals were less generalized. On the surface of L-LMet, L-C and LMet-C samples, the salts appear as generalized "hair crystals" at the end of 4th cycle and dense crust at the end of 6th cycle on the upper part of the render, appearing higher than those with the same render formulation on both sides, as L, L-L or LMet-LMet.

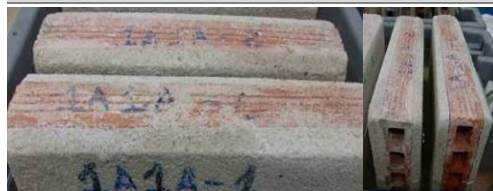
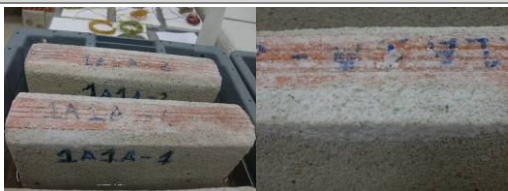
Mortar	++(L)	++++	(L)
Brick	+	+++

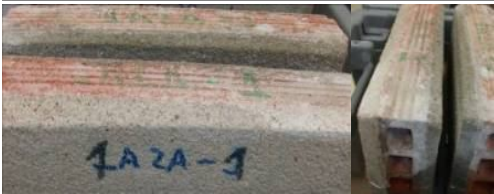
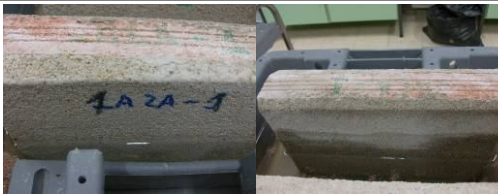
Mortar	++(L); ++(LMet)	++++(L); +++(LMet)	
Brick	++	+++	
Specimen L-C

Mortar	++(L); +(C)	++++(L); ++(C)	
Brick	+	++++	
Specimen L-CRes

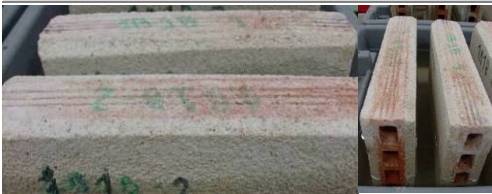
Mortar	+++ (L); -(Cres)	+++++(L); +(Cres)	
Brick	++	++++	
Specimen LMet-LMet

Mortar	++(LMet)	+++ (LMet)	
Brick	+	+++	
Specimen LMet-C

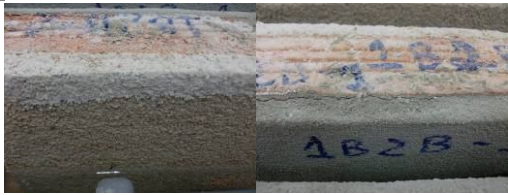
Cycles	4 th cycle	6 th cycle
Specimen LMet-CRes

Mortar	+(LMet); -(CRes)	++++(LMet); +(Cres)
Brick	+++	++++
Specimen C-C

On C-C, L-CRes, LMet-CRes, C-CRes, Cres-CRes and CRes, where at least one render coat was based on cement, the salts formed a dense crust on the top of the brick, although salt crystallization variations between the samples did occur, at the end of 6th cycle. In CRes-CRes and CRes specimens almost no salt crystallization can be seen on the surface of the render, while on C-C there was some salt accumulation on the surface. CRes render prevented the salt transport to the surface and caused high crystallization on the top of the brick, at the end of 6th cycle.

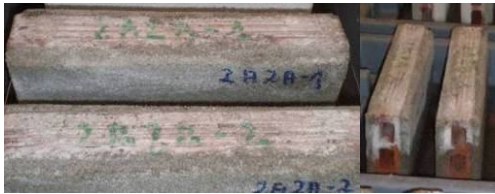
Mortar	++(C)	++(C)
Brick	++	++++
Specimen C-CRes

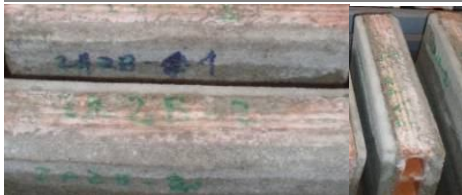
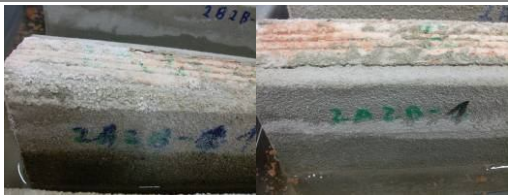
Mortar	+(C); -(CRes)	++(C); +(CRes)
Brick	++	++++
Specimen CRes-CRes

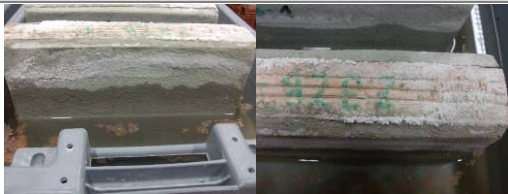
Mortar	-(CRes)	+(CRes)
Brick	++	++++
Specimen CRes

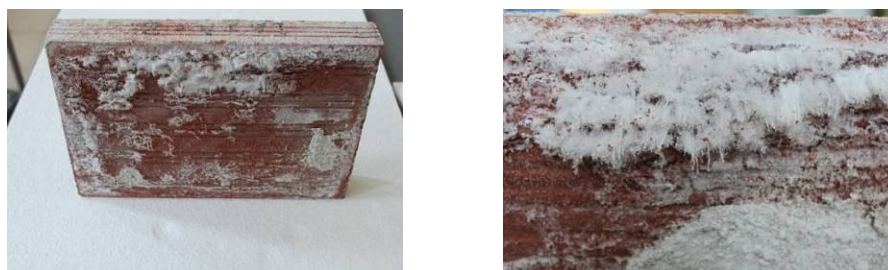
Fig. 5.8 Efflorescence on the brick after render detachment

Another interesting observation was the presence of high quantity of salt efflorescences as “fluffy efflorescence” in L-L specimen. In this specimen the detachment of the outer layer occurred at the end of the tests. The presence of NaCl salts in the support as well as on renders surface due to salt solution absorption and the relative humidity flotation in the non-conditioned room contributed to this (Figure 5.8).

In NaCl contaminated specimens the relative humidity changes, even in the absence of any other moisture source, and it was observed to cause an increase on salt accumulation in the outer surface. This phenomenon was investigated by Lubelli [Lub07], who observed that if salts having a RH of crystallization in a range easily crossed by the air RH, induces salts accumulation just beneath the surface of the material: i) RH changes through the RH of crystallization, may dissolve and re-crystallize the salts in the pores of the material causing damage and ii) the hygroscopic effect due to RH changes is clearly increased by the presence of salt near the surface.

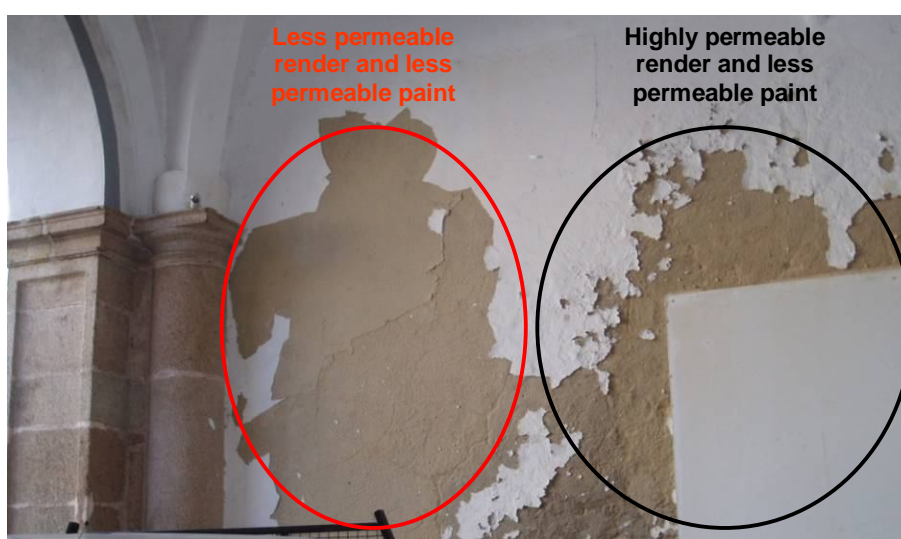
Fig. 5.9 Damage in pre-existent highly permeable render due to application of less permeable render and paint (a panel was used for hiding the anomalies above the pre-existent render)

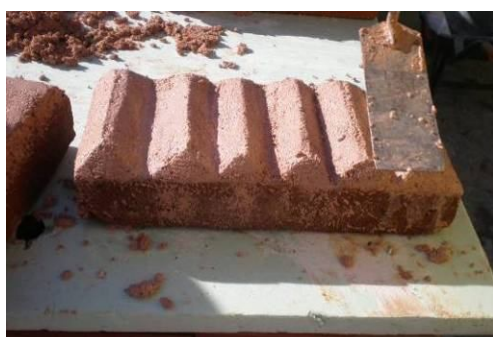
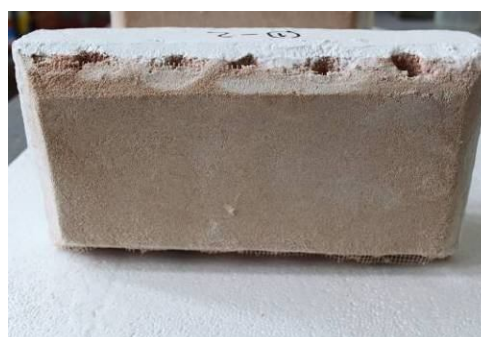
Fig. 6.11 Execution of the render system with vertical grooves (left); Final appearance of render system with vertical grooves (right)

In Table 6.3 the composition of the studied specimens is presented, and in Fig. 6.10 is presented a schematic representation of these specimens that were submitted to accelerated salt crystallization tests in laboratory. The render systems in specimens were carefully executed (see render systems application and execution in see chapter 7) in order to reduce problems during testing, which could be related to inadequate workmanship (Figs. 6.11 and 6.12).

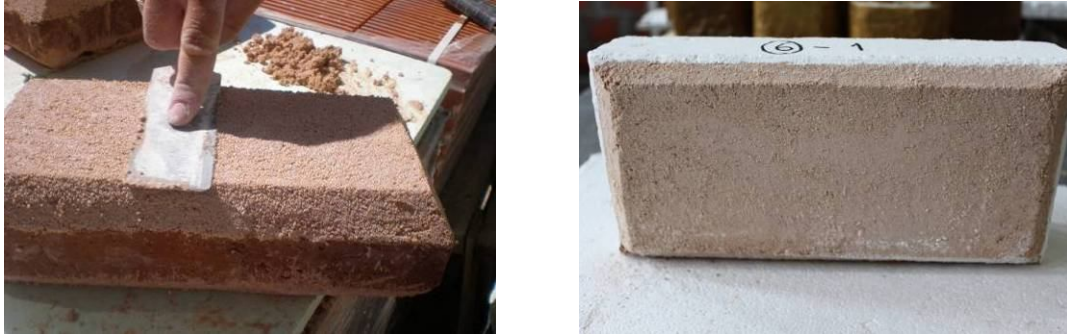
Fig. 6.12 Execution of render system without vertical grooves (left); Final appearance of render system without vertical grooves (right)
